New York State Department of Transportation

Yellow Flag NB2228W016

BIN: 1065318

Feature Carried: 278I278IX2M23027

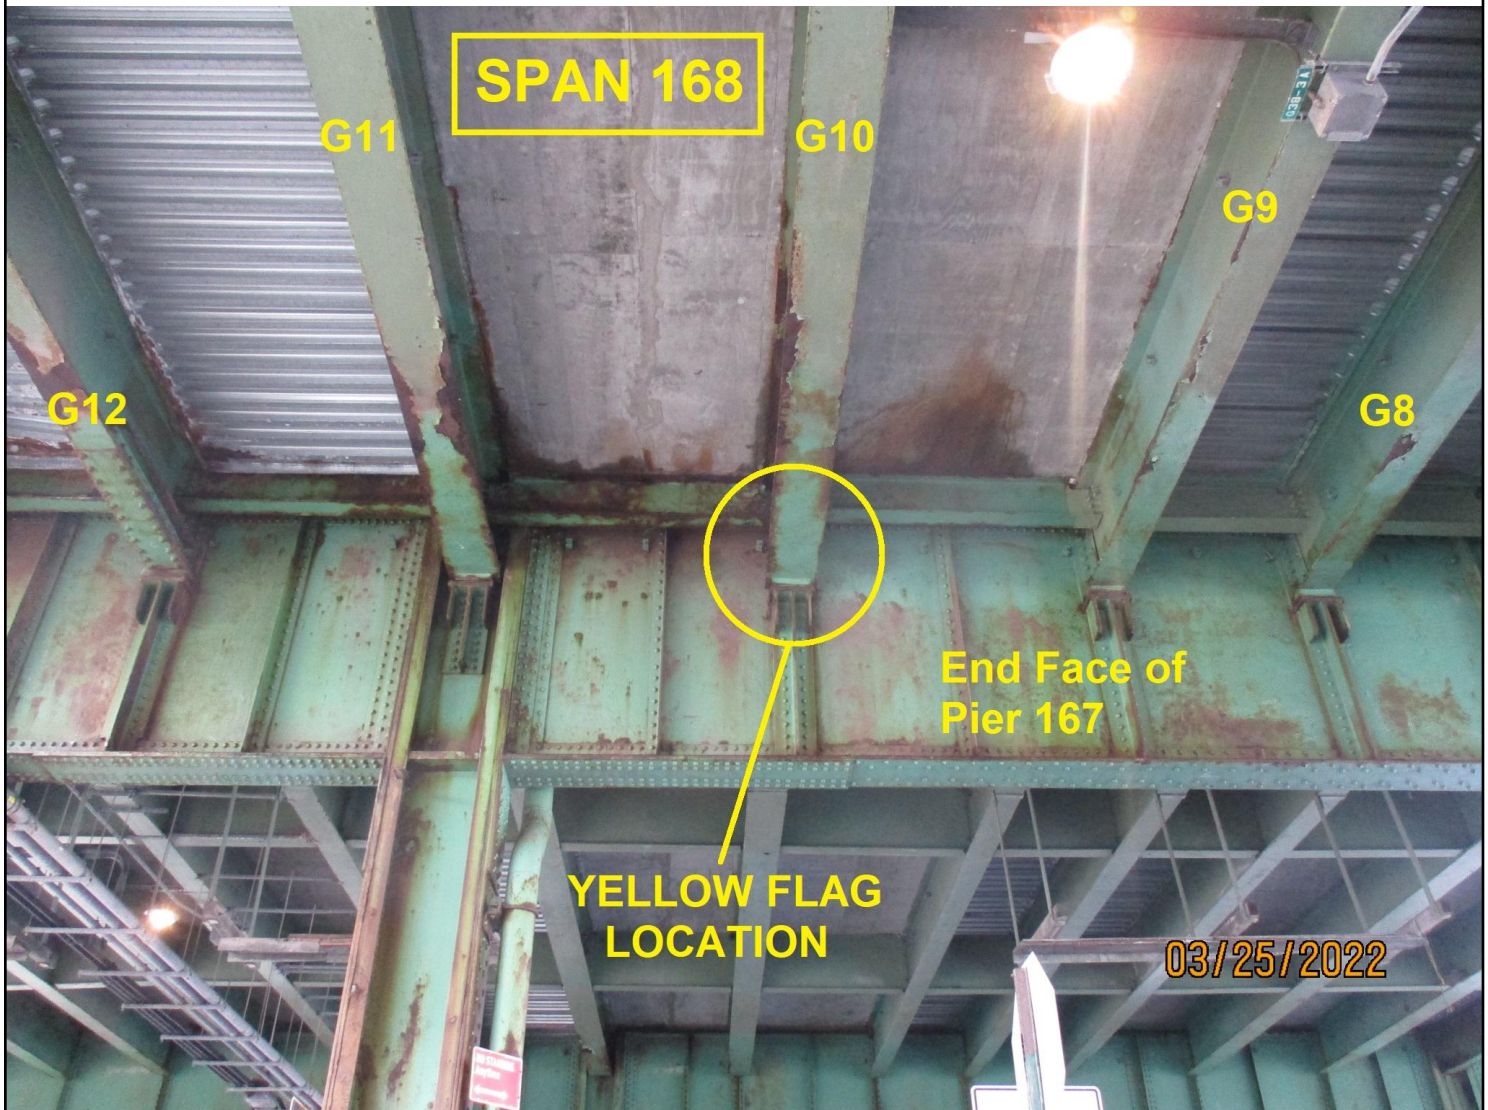
Photo Number: 1

Attachment Description: General view of the flagged condition at Girder G10 in Span 168 at Pier 167. Looking Begin.

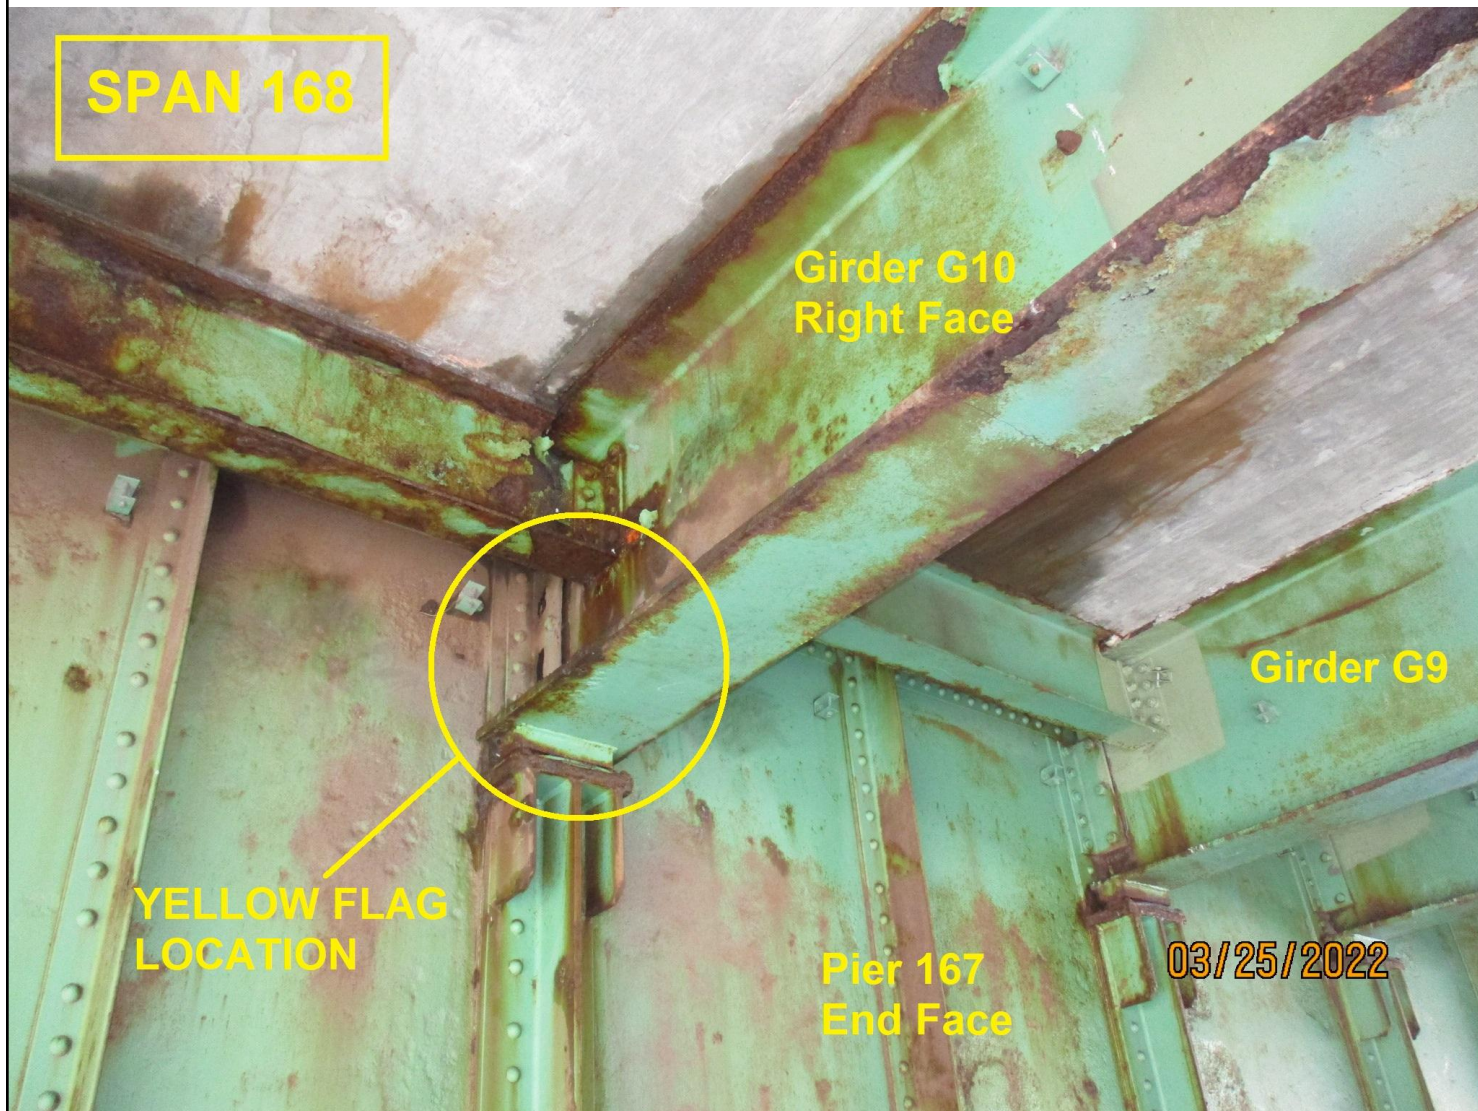
Photo Number: 2

Attachment Description: Close up general view of the flagged condition at Girder G10 in Span 168 at Pier 167. Looking Begin Left.

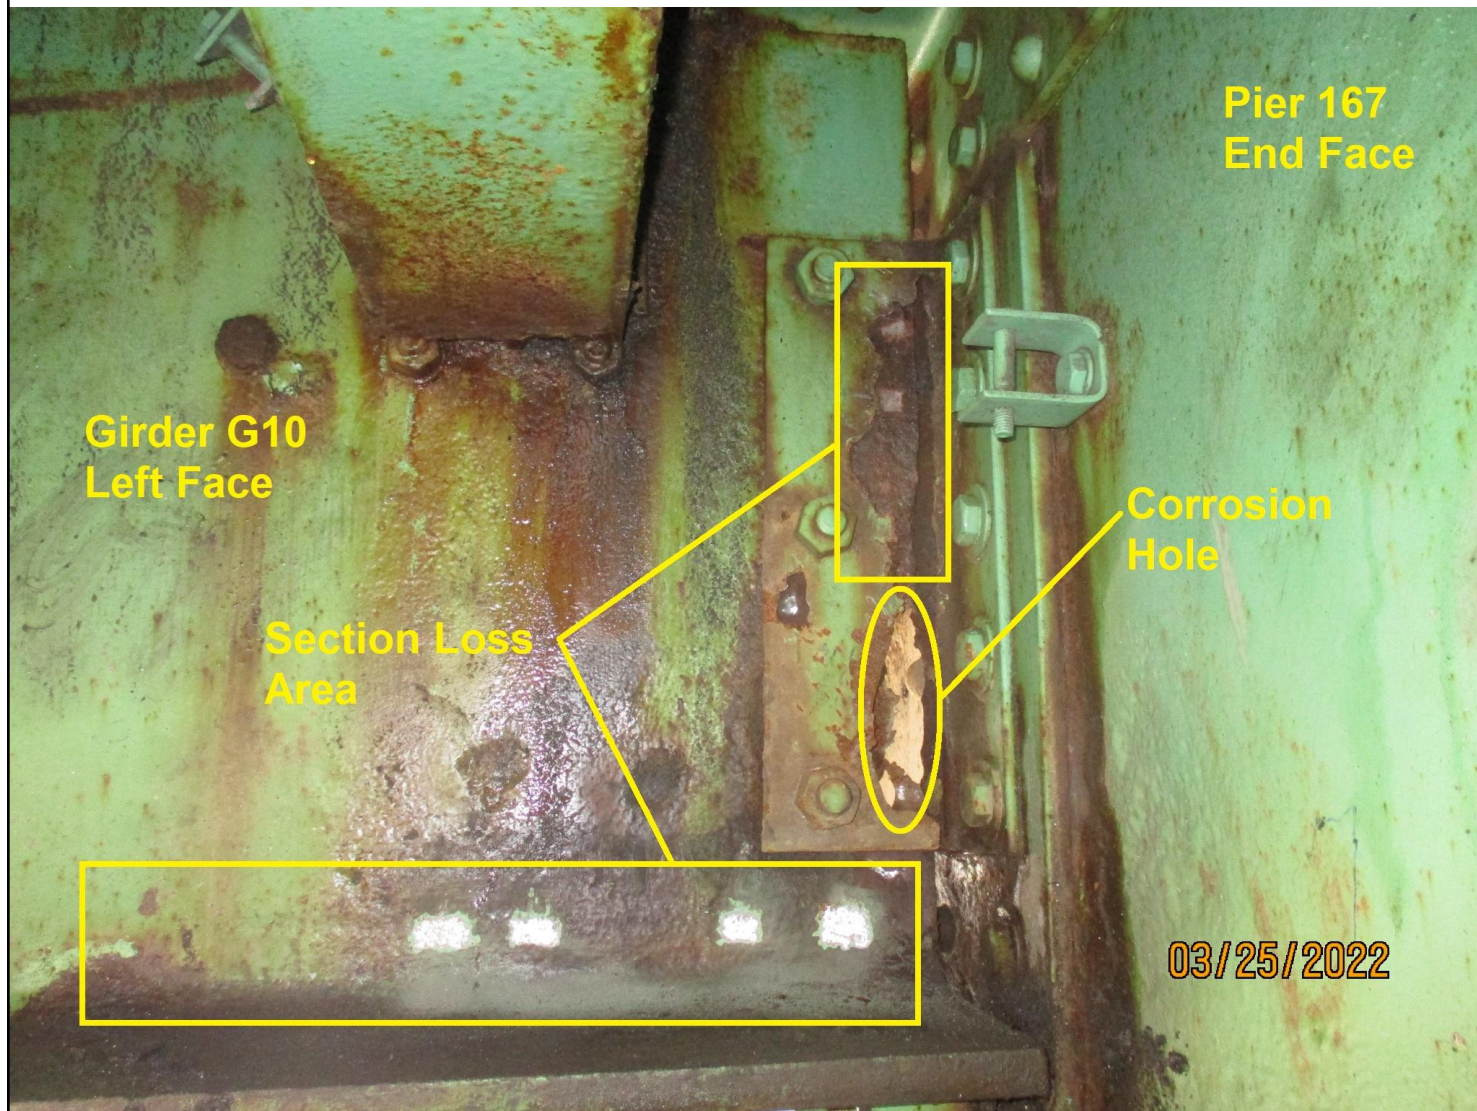
Photo Number: 3

Description: The end of Girder G10 in Span 168 at Pier 167 exhibits severe corrosion resulting in an overall shear web area section loss of approximately 52% (previously 61%) and an overall lower portion of the web in the bearing area section loss of approximately 24% (previously 20%). The web of the girder exhibits 6-1/2" long x 1-3/4" wide corrosion hole approximately 6" from the bottom flange (Photos 3 and 4). The remaining thickness measurements (RTM) along with the percent section loss calculations are shown in the attached girder sketch (Refer to sketch for more details). This girder is located above an expansion bearing.

Attachment Description: The left face of Girder G10 in Span 168 at Pier 167. The girder web exhibits severe section loss with corrosion hole above the bearing area. Looking Right.

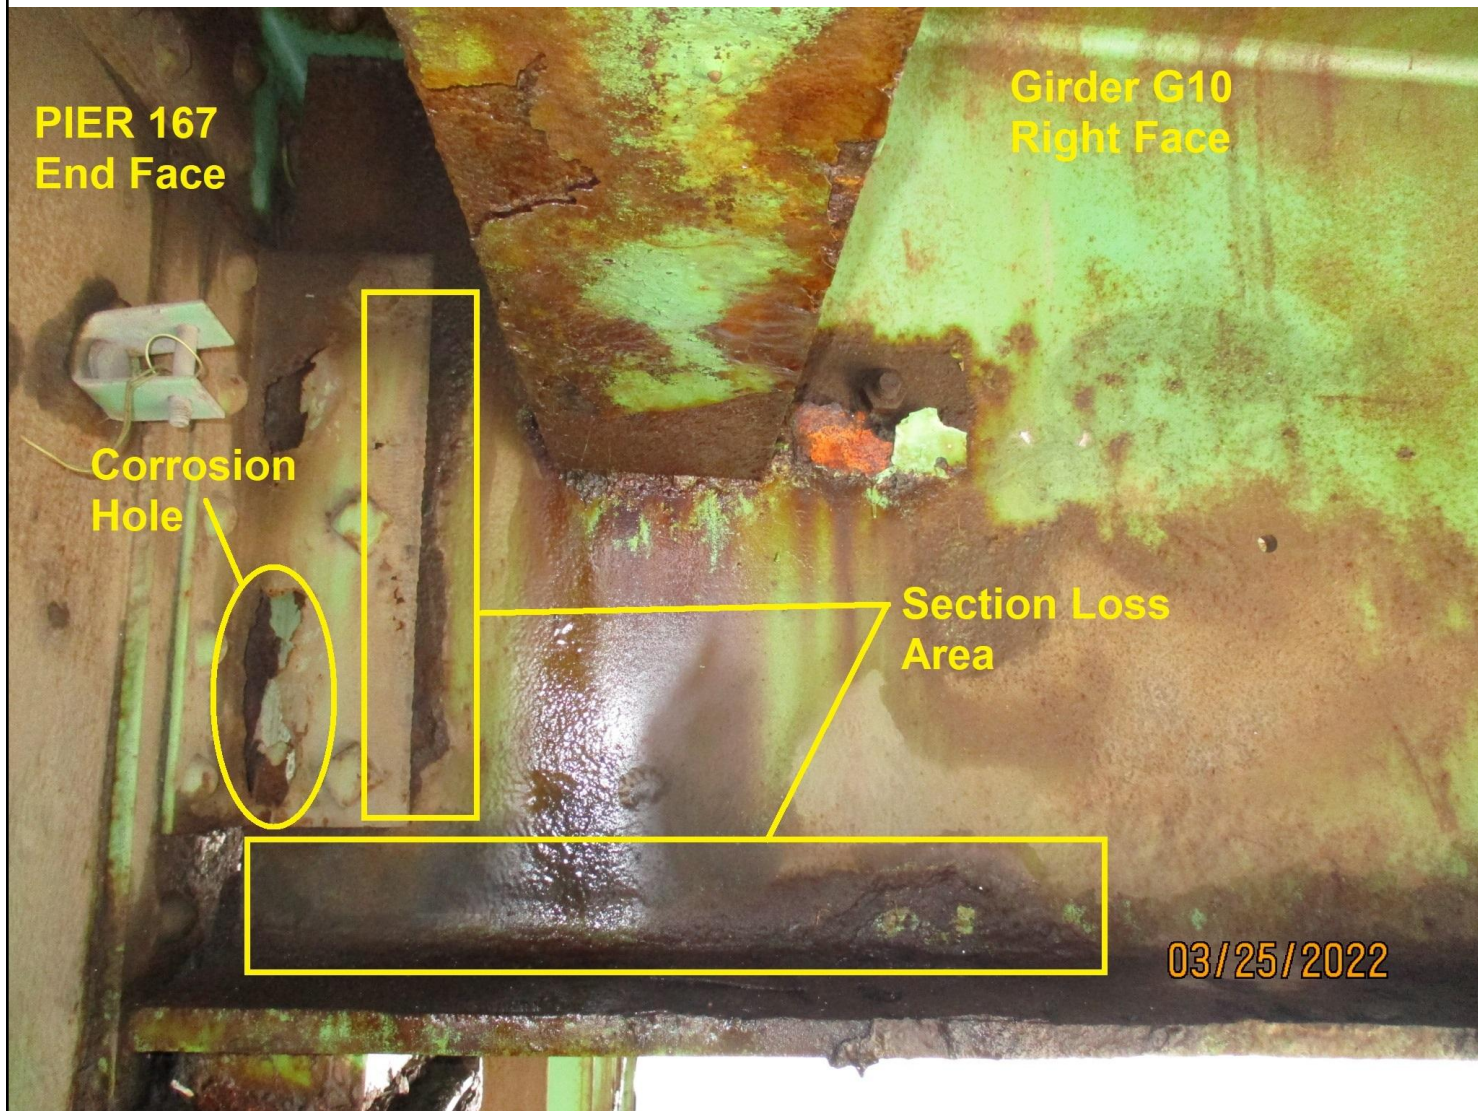
Photo Number: 4

Attachment Description: The right face of Girder G10 in Span 168 at Pier 167. The girder web exhibits severe section loss with corrosion hole above the bearing area. Looking Left.

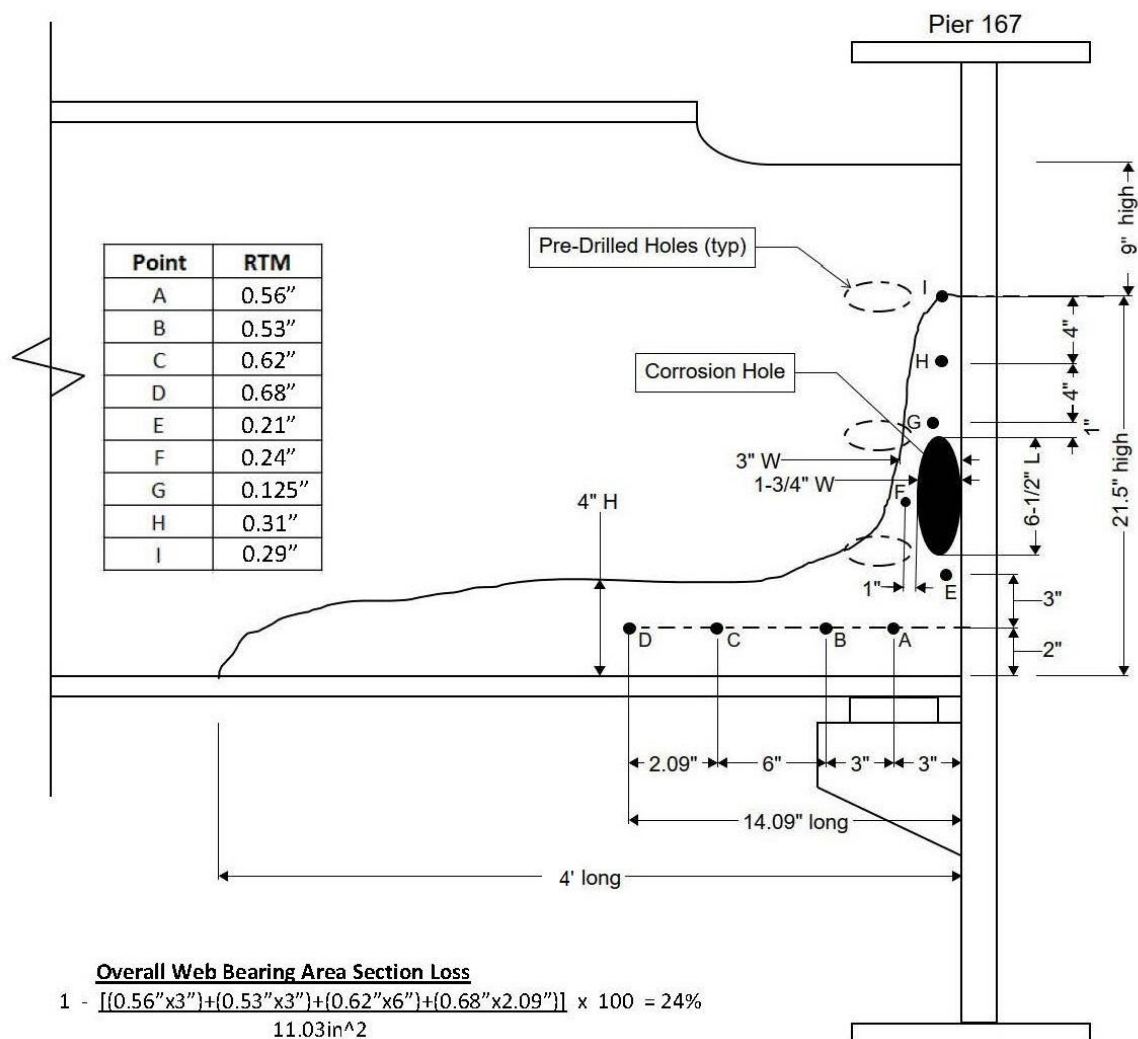
Photo Number: 5

The depth of the girder has been revised to 30.5" (previously 25") which reduced the shear section loss from 61% to 52%.

- As-built web thickness = 0.783"
- Length of bearing area = 18 x web thickness = 18 x 0.783" = 14.09"
- Overall bearing area = 14.09" x 0.783" = 11.03 in²
- As-built shearing web area = 30.5" x 0.783" = 23.88 in²
- The guide angles at the face of the girder were not shown for clarity purposes.

Attachment Description: SN168 G10 at Pier 167 Sketch

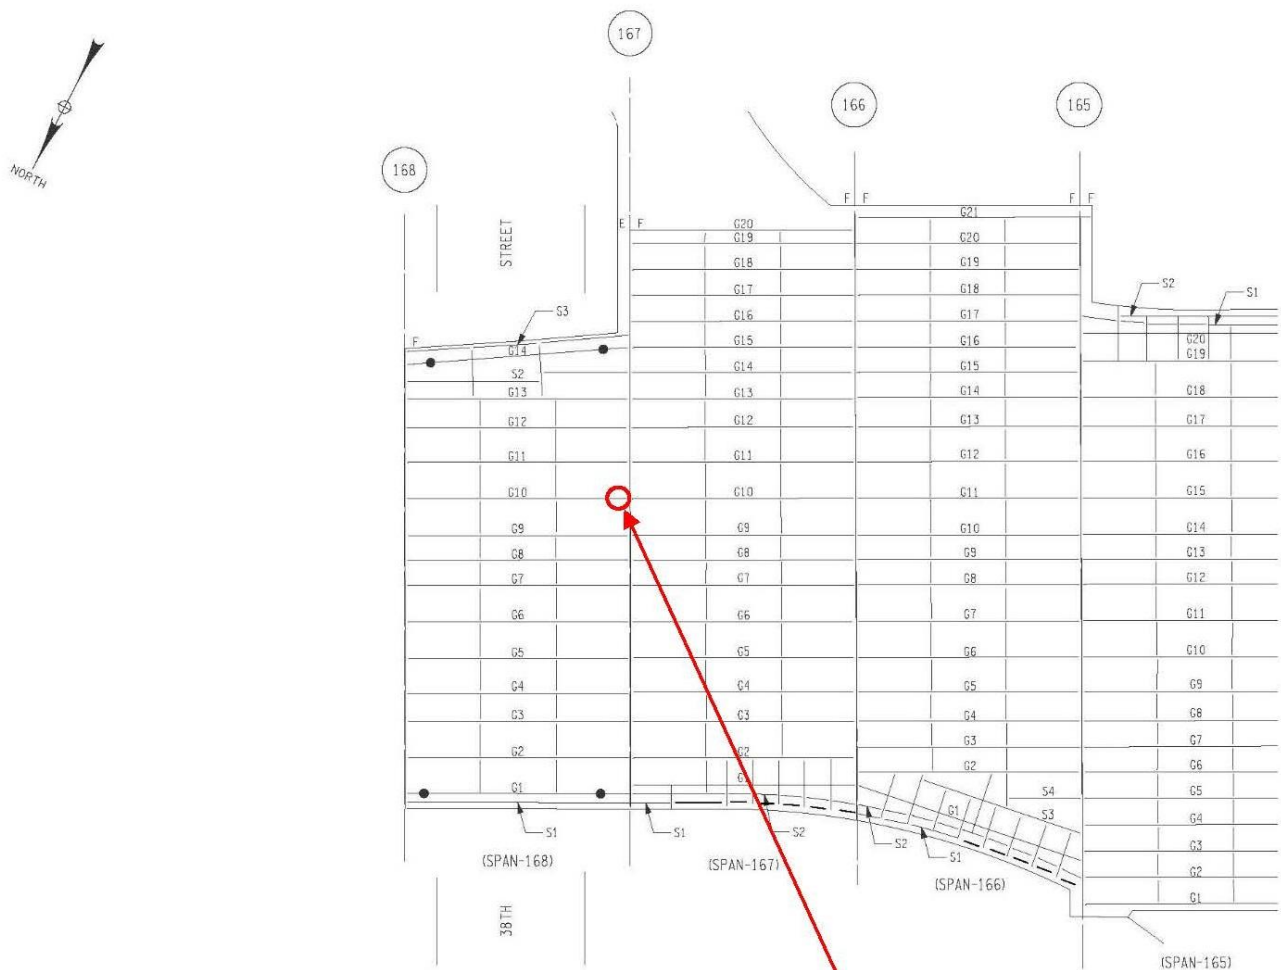
Photo Number: 6

**YELLOW FLAG
LOCATION**
No. NB2228W016

Attachment Description: SN168 G10 at Pier 167 Framing
